# Failure cause assessment of steam reformer radiant tube after long-term service

This study investigates the damage, microstructure, and mechanical evolution of service-exposed HP40NbTi radiant tubes of a steam reformer furnace. Tube failure was reported after 6-year of working at 525°C–830°C in the form of visible longitudinal and transverse cracks. The microstructure was evaluated using optical and scanning electron microscopy equipped with energy-dispersive X-ray spectrum analysis. The carbide phase transformation was determined by the method based on the matrix dissolution technique and X-ray diffraction. The results of this study showed that the primary cause of the longitudinal crack formation is the local overheating and the oxidation of the dendritic grain boundaries. The  $M_7C_3$  carbide transforms completely into the metastable  $M_{23}C_6$  phase during high-temperature service. Metallographic examinations revealed the shrinkage cavities and creep voids that are nucleated on both Cr- and Nb-carbides. The continuous oxide layers of  $Cr_2O_3$  and  $SiO_2$  formed near the inner and outer tube surfaces and the matrix's chemical composition near the outer tube surface

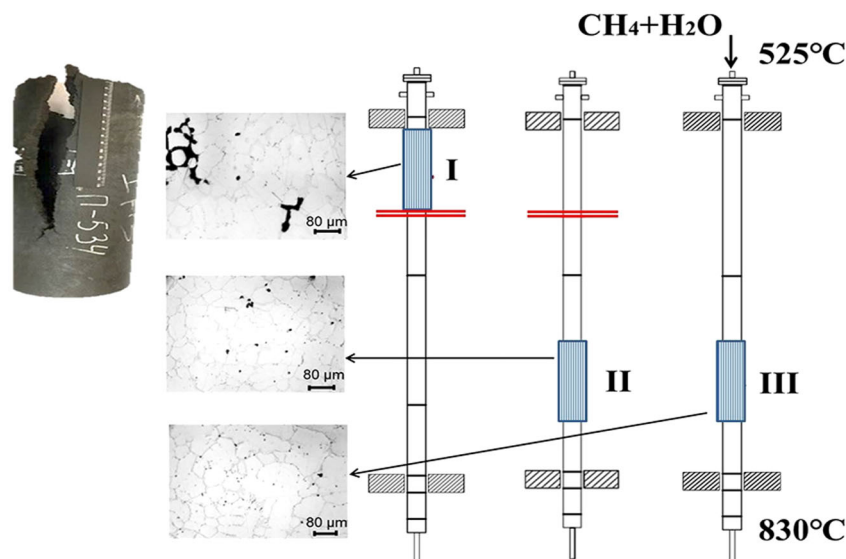
**FIGURE 1** Schematic representation of the radiant tubes, positions of the samples with the corresponding optical microscopy images, and the picture of the failure tube (Specimen-I) [Color figure can be viewed at [wileyonlinelibrary.com](http://wileyonlinelibrary.com)]

Fractographic analysis was done for failed Specimen-I, shown as an image in Figure 1. As can be seen, visual cracks have propagated longitudinally, oriented along the pipe axis, and transversely, oriented in a perpendicular plane. Figure 2 illustrates the results of fractographic analysis in the area of the longitudinal (left-side pictures) and perpendicular (right-side picture) cracks. As shown in Figure 2a, the depth of the damaged metal relative to the outer surface is approximately uniform and equals 5(1) mm for the longitudinal crack. For perpendicular

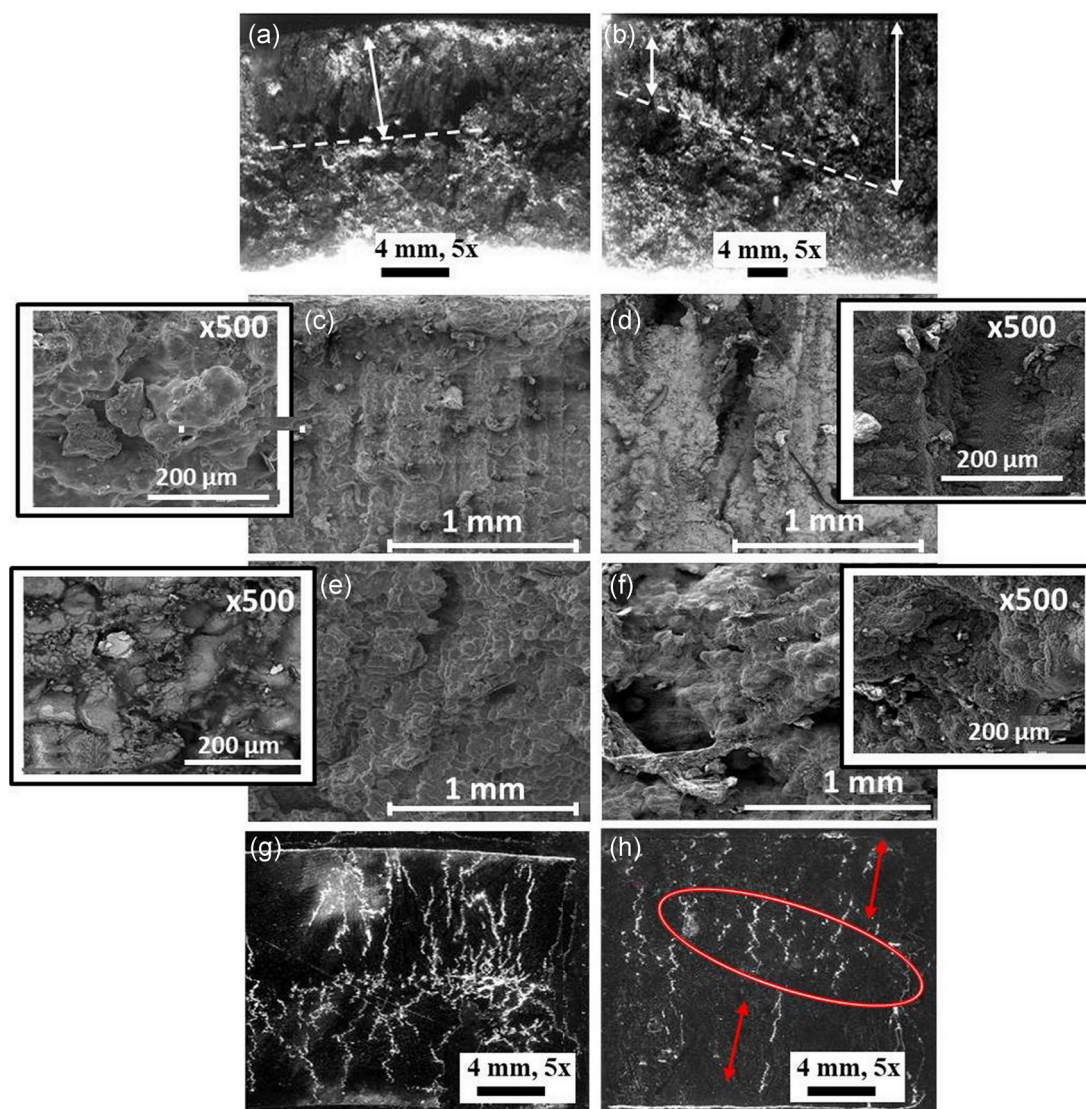
**FIGURE 2** Fractographic analysis of the failed Specimen-I in the area of the longitudinal (left-side pictures) and perpendicular (right-side picture) cracks. (a,b) Fracture surface; (c–f) scanning electron fractographs (secondary electron mode) accompanied with high magnification (small frames) in the region close to the outer tube surface (c,d) and in the crack opening region (e,f). (g,h) Metallographic images; the oval shows the tearing-off zone under torsion and the arrows indicate the tearing-off zone under tension [Color figure can be viewed at [wileyonlinelibrary.com](http://wileyonlinelibrary.com)]

crack, the damaged metal depth varies within 2(1)–10(1) mm, which indicates local damage of the tube (see Figure 2b).

To investigate the cracking modes, the Specimen-I surface was examined by SEM (SE mode). Figure 2c–f illustrates the SEM images of the failure surface at two different magnifications ( $\times 100$  and  $\times 500$ ). Analysis of the surface in the area of the longitudinal crack in Figure 2c,e revealed that the material damage close to the outer surface of the pipe body corresponds to the ductile intergranular deformation with the formation of a stone-like fracture (Figure 2c). In the crack opening region, the local dimples are observed on the fracture surface (see Figure 2e) and the fracture is characterized as quasi-brittle.

Near the transversal crack, there is no indication of molten metal that defines this rupture as secondary. The microstructural observations made at both magnifications show the quasi-brittle fracture surface (Figure 2d,f), which is most clearly seen close to the crack opening region (Figure 2f).

To clarify the probable causes of the crack appearing, a metallographic analysis was performed and resulted on Figure 2g,h. Two samples of tube surface were taken as follows: the pattern No. 1 is cut out at the place of the greatest longitudinal crack opening and the pattern No. 2 is done from the transversal crack fracture. The damaged metal assessment was carried out on nonetched patterns based on the qualitative judgment of the number and locations of the identified intergranular destruction traces. Figure 2g shows that the destruction traces density is located in a plane parallel to the outer surface of the tube body (the upper border of the figure). It is noteworthy that the density increases from the internal side. This indicates a relatively rapid crack opening at the outer surface of the tube and a slow one at the inner surface. For the pattern No. 2 (Figure 2h), the greatest damage was observed only on one side closer to the local destruction. On the image, the oval shows the tearing-off zone under torsion and the arrows indicate the tearing-off zone under tension. As cracks open under normally applied stresses, it is possible to suggest that the tube deformation was succeeded by bending or rotation. This suggestion is in agreement with the fractographic results.

The aforementioned results suggest that the metal destruction occurred in two stages. First, the cavity appeared with the subsequent opening of the longitudinal crack due to increased internal pressure of the service environment. The longitudinal crack is a ductility-dip cracking with the stone-like fracture surface near the outer tube surface. At the next region of crack opening, the fracture transformed into a quasi-brittle. The subsequent structure destruction is the result of the bending

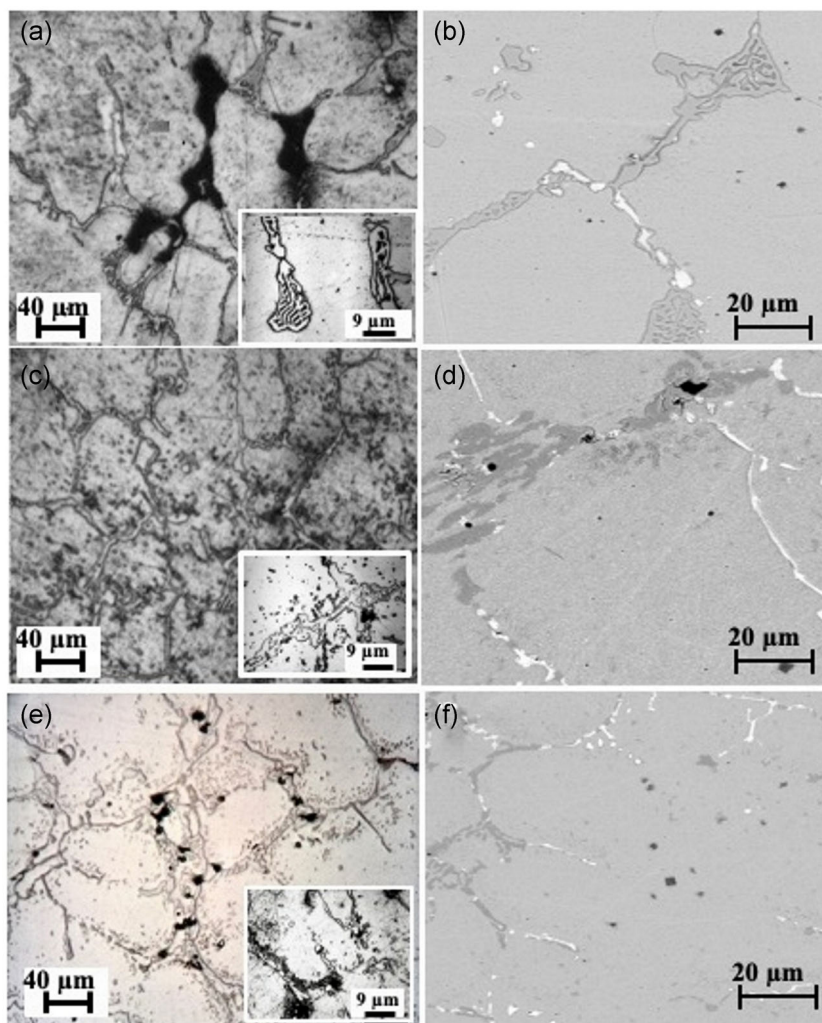
Figure 3 illustrates the optical (left row) and scanning electron (right row) microscopy of the central area of Specimen-I (Figure 3a,b), Specimen-II (Figure 3c,d), and Specimen-III (Figure 3e,f). The small frame pictures for optical microscopy images are run with higher magnifications. It can be seen that the microstructure of all studied specimens consists of an austenitic matrix and a continuous network of eutectic carbides, marked by dark and white colors on SEM images. Figure 3 also demonstrates the precipitations of many small dispersive particles located near the dendritic boundaries and the microporosity resulted from interdendritic shrinkage during alloy crystallization. The shrinkage porosity is one of the main problems in the centrifugal casting of long empty thick-walled cast blocks.<sup>[16]</sup>

**FIGURE 3** Microstructure of the Specimen-I (a,b), Specimen-II (c,d), and Specimen-III (e,f): left-side pictures— $\times 100$  optical microscopy images ( $\times 400$  in frame); right-side picture—scanning electron microscopic images (backscattered electron mode) [Color figure can be viewed at [wileyonlinelibrary.com](http://wileyonlinelibrary.com)]

The microstructure image in Figure 3 shows a lot of voids in contact with the blocky Cr-rich  $\text{M}_{23}\text{C}_6$  and Nb-rich carbides that indicate the creep development. The mechanism of the creep-induced embrittlement is linked to the generation and coalescence of intergranular voids with the formation of large cavities near the precipitates.<sup>[19]</sup> During the material exploitation at high temperature, the creep voids evolve into micro- and then macrocracks.<sup>[3]</sup> The cavities around precipitates are formed due to the alloying element diffusion at the eutectic carbide/matrix and dispersive precipitate/matrix interfaces.

Coarse carbides enriched by Cr and Nb can be nucleators of voids in the material during the creep process.<sup>[3]</sup> This study suggests that the creep voids are nucleated on both Cr- and Nb-carbides, as shown in Figure 3. Carbide coalescence and coarsening mechanisms are diffusion-dependent. Even a slight increase of service temperature can significantly affect the kinetics of particle growth and thus accelerate the nucleation of creep voids.<sup>[20,21]</sup> Therefore, the service temperature is the key factor influencing the equipment lifetime at high-temperature exposure with an aggressive environment.

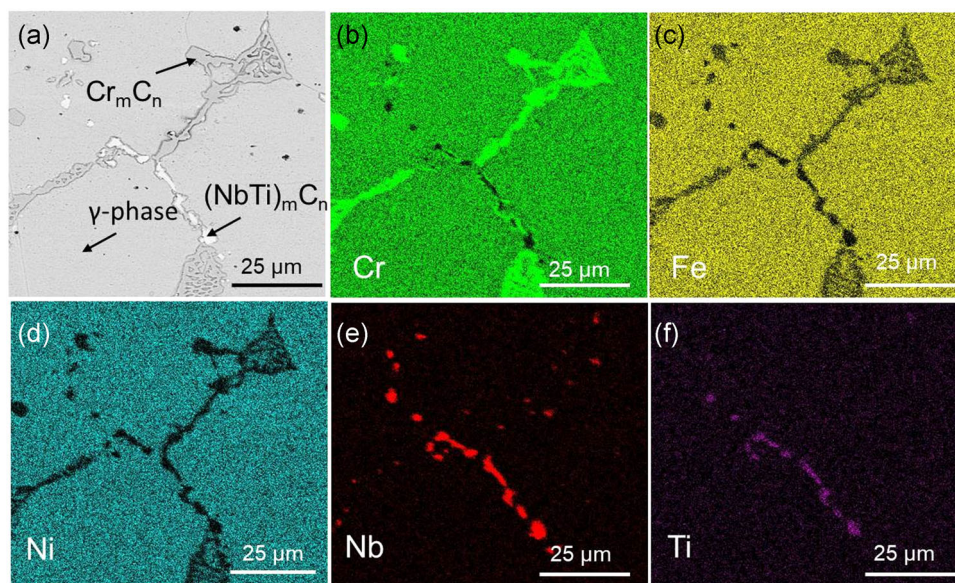
Elements distribution of specimens was measured by EDS mapping and resulted in Figure 4. EDS analysis reveals that the eutectic phase is a mixture of chromium (dark phase) and niobium-titanium (NbTi)C (white phase) carbides. XRD analysis of the particles extracted from the studied specimens shows that the main carbide is  $M_{23}C_6$  (M mostly is Cr) and the volume fraction of (NbTi)C is too low to be detected, as shown in Figure 5. Diffraction analysis of the  $M_{23}C_6$  carbide presents this phase has an FCC structure with a lattice parameter of 1065 nm.

**FIGURE 4** EDS mapping of the elemental distribution (b–f) of the Specimen-I in the central surface area. (a) Scanning electron microscopic image (backscattered electron mode). EDS, elements distribution of specimens [Color figure can be viewed at [wileyonlinelibrary.com](http://wileyonlinelibrary.com)]

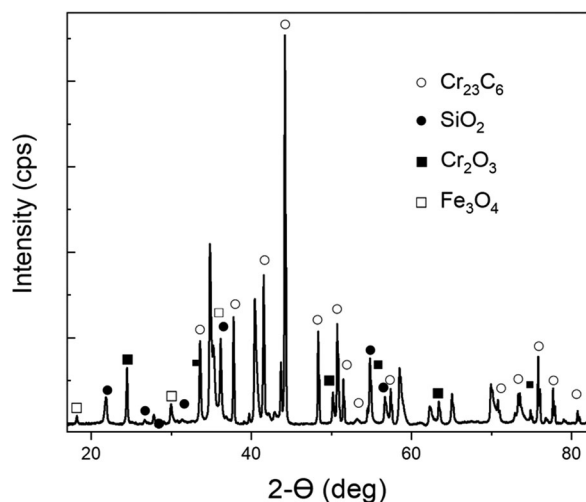
Figure 5 depicts the XRD analysis of extracted carbide phase for Specimen-II. In addition, signals identified as phases of  $SiO_2$ ,  $Cr_2O_3$ , and mixed-valent  $Fe_2O_3$  are observed. The presence of the  $Cr_2O_3$  signal is probably explained by the penetration of oxide particles from the studied specimen into the carbide phase without compound changing since chromium (III) oxide is acid-resistant and slightly interacts with a dilute solution of inorganic acids.<sup>[17]</sup> The presence of the  $SiO_2$  phase might be due to its formation during the oxidation of elemental silicon on the sample surface at anodic dissolution. At the same time, the  $SiO_2$  formation in oxidation processes during the facility exploitation is possible and its subsequent entry into the carbide phase. It is suggested indirectly by the EDS results, as will be shown in Figure 6. Similar results were obtained in Song.<sup>[13]</sup> The signals corresponding to  $Fe_2O_3$  can be explained by the aerobic oxidation of highly dispersed reactive particles of the iron-containing carbide phase during the rinsing of the extracted sample or their storage at high humidity.

**FIGURE 5** X-ray diffraction analysis of extracted carbide phase for the Specimen-II. It is noteworthy that  $\text{SiO}_2$  and  $\text{Cr}_2\text{O}_3$  are the results of internal oxidation;  $\text{Fe}_2\text{O}_3$  is the result of the inadequate rinsing of the extracted sample

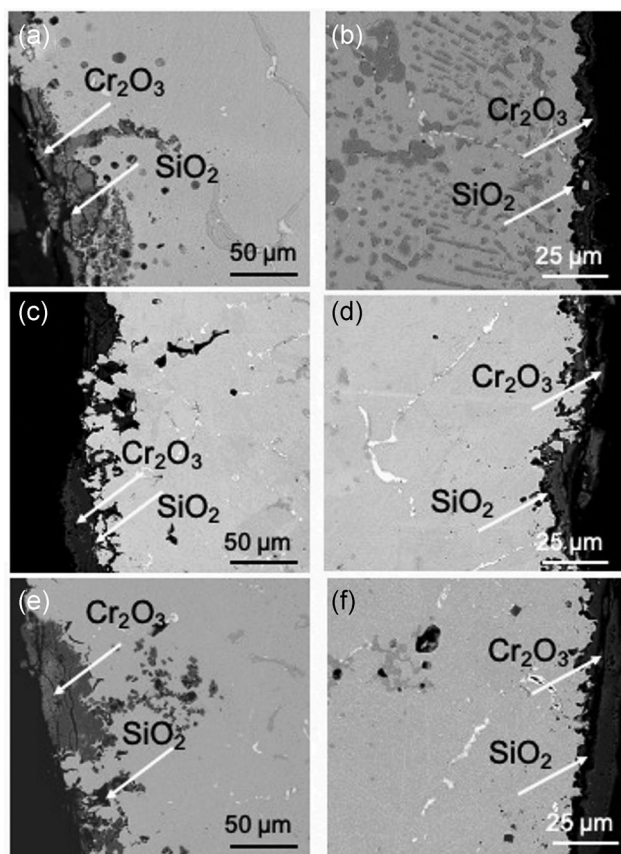
**FIGURE 6** Scanning electron microscopic images (backscattered electron mode) of the specimens near the outer (left-side pictures) and inner (right-side pictures) tube's surfaces: (a,b) Specimen-I; (c,d) Specimen-II; (e,f) Specimen-III

of the specimens near the outer (left row) and inner (right row) tube's surfaces are presented in Figure 6. The element distribution was measured using EDS mapping analysis. It can be seen that the continuous chromium-rich oxide layer and the fragmental silicon-rich oxide layer formed on the inner and outer tube surfaces. These oxides are  $\text{Cr}_2\text{O}_3$  and  $\text{SiO}_2$ ,<sup>[13]</sup> which supported the XRD results presented in Figure 5. Figure 7 illustrates in more detail the element distribution map for the Specimen-III. As shown, the matrix near the inner and outer tube surface layer is depleted of Cr due to the formation of the oxides. Near the outer tube surface, the Al particles from the destroyed catalyst and TiN particles are observed. The high-temperature corrosion had led to inner and outer surface decarburization and the subsurface regions free from precipitates are observed. Also, some creep voids appeared in this region normally formed at the original location of the dissolved carbides.

Similar morphologies of the inner and outer tube surfaces are observed for other specimens, as illustrated in Figure 6, except for the width of the decarburized region. For the failure Specimen-I, the narrower decarburized region (no more  $15\ \mu\text{m}$ ) is observed, beneath which the increased density of dispersed precipitates appeared that indicates the carburization of the inner tube surface.

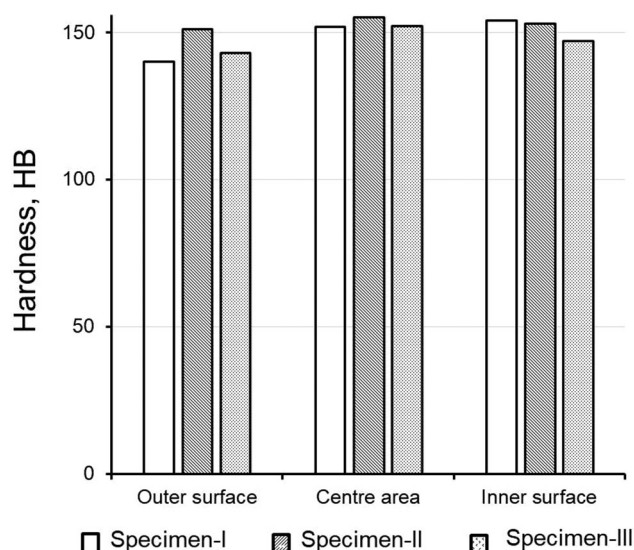
Figure 8 shows the comparison of the Brinell hardness between specimens for the center, inner, and outer surface regions. It can be seen that the hardness values are distributed uniformly, except the region near the outer tube surface where hardness for Specimen-I and -III decreases by  $\sim 10\%$ .

**FIGURE 8** Brinell hardness of the specimens for the center, inner-, and outer-surface regions

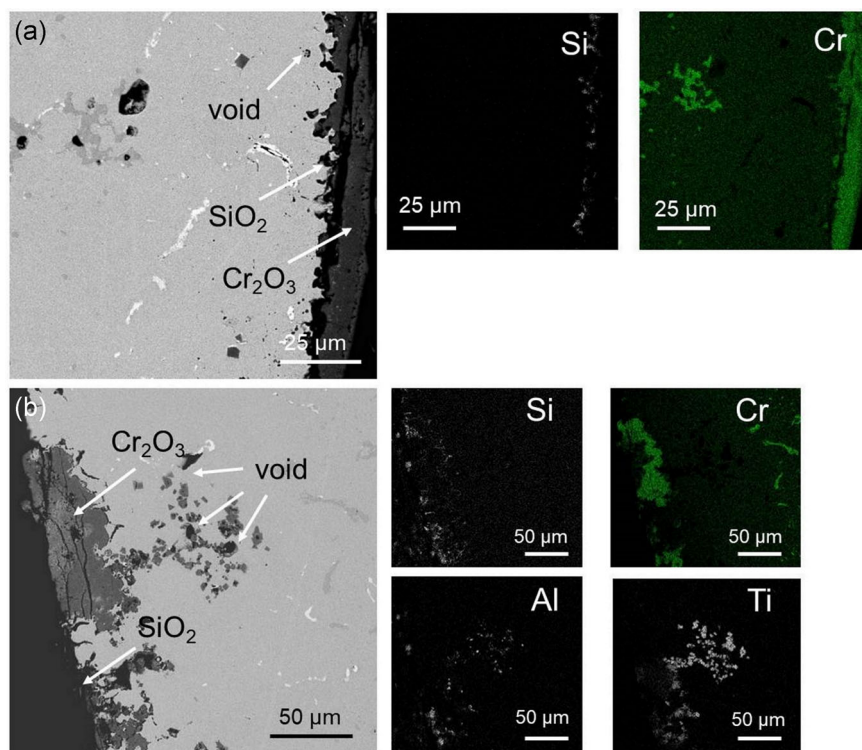
**FIGURE 7** Scanning electron microscopic images (backscattered electron mode) and the element distribution EDS map for the Specimen-III near the inner (a) and outer (b) tube's surfaces. EDS, elements distribution of specimens

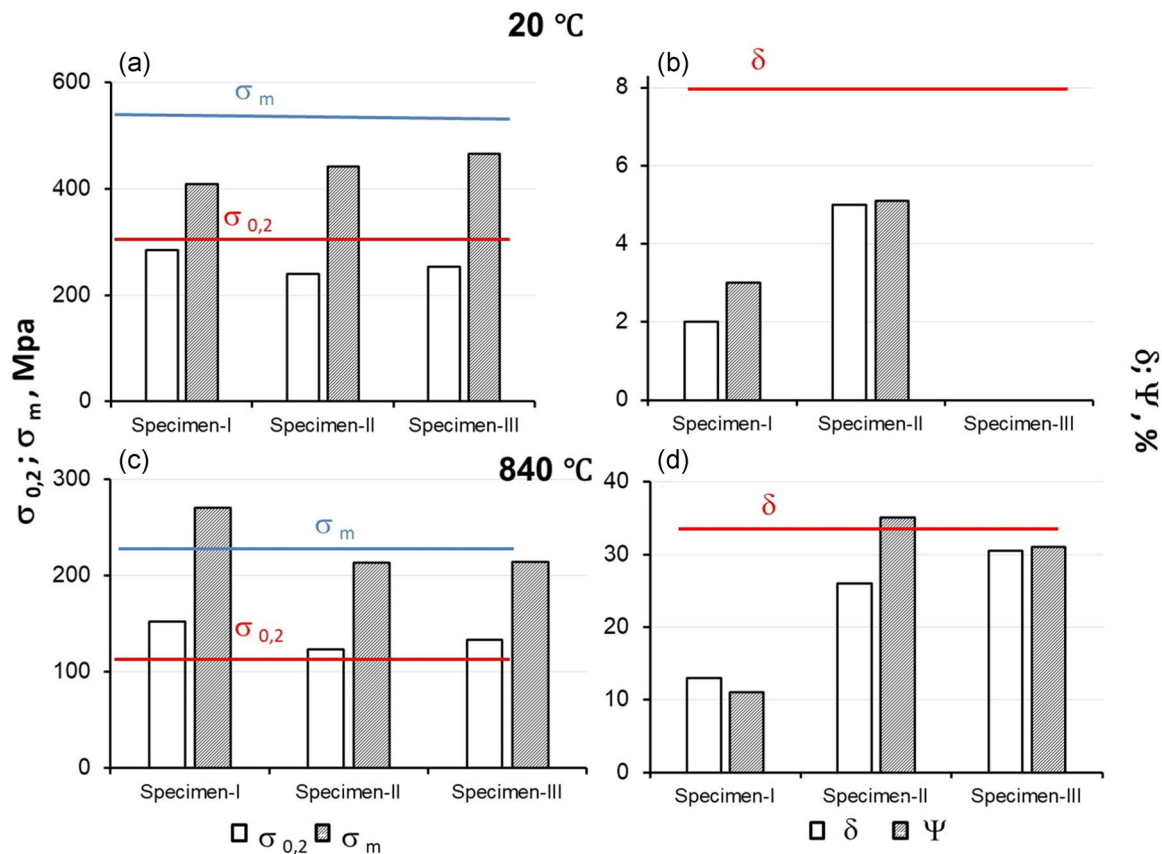
**FIGURE 9** Tensile properties of the studied tubes at 20°C (upper pictures) and 840°C (low pictures). The color lines depict the literature values for similar alloys. (a,c) Yield strength ( $\sigma_{0.2}$ ) and tensile strength ( $\sigma_m$ ) parameters; (b,d) residual elongation ( $\delta$ ) and residual constriction ( $\psi$ ) parameters [Color figure can be viewed at [wileyonlinelibrary.com](http://wileyonlinelibrary.com)]

Tensile properties of the studied tubes at room (upper pictures) and service (low pictures) temperatures are illustrated in Figure 9. The color lines depict the literature values for similar alloys.<sup>[22]</sup> It can be seen that the yield strength ( $\sigma_{0.2}$ ) and tensile strength ( $\sigma_m$ ) for specimens are comparable or slightly below the literature data for both temperatures, as shown in Figure 9a,c. The ductility properties, such as residual elongation ( $\delta$ ) and residual constriction ( $\psi$ ), are presented in Figure 9b,d for both temperatures. It is shown that for the service temperature the ductility for Specimen-I decreases remarkably while the ductility for Specimens-II and -III are in agreement with the literature, as shown in Figure 9d. Figure 9b presents the dramatic loss of ductility for room temperature. The samples of Specimen-III were destroyed during the tensile test. The ductility dip is due to the variations of the type, shape, and size of the precipitates and is the important factor. If the ductility is too low, the tube cannot be operated.
